**Mack GU813 Mounting Location**

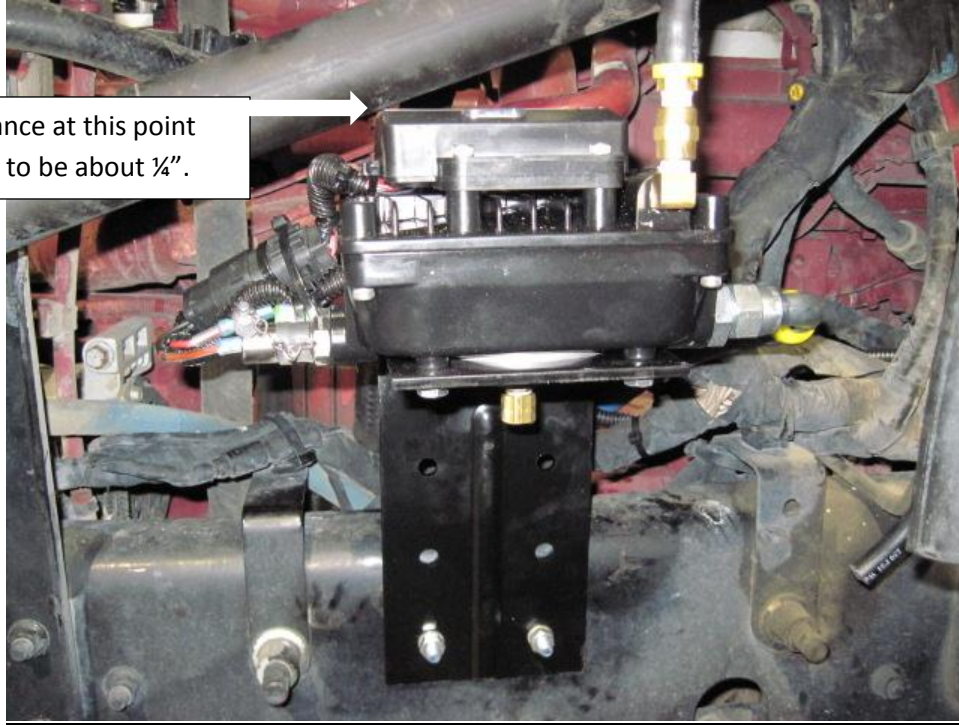
### Mounted Unit

Clearance at this point  
needs to be about  $\frac{1}{4}$ ".
